# INSTRUCTION SHEET

## ROOM EXTENSION SOLENOID VALVE REPLACEMENT

This sheet is to be followed only when changing the small solenoid valves used for a room extension manifold.

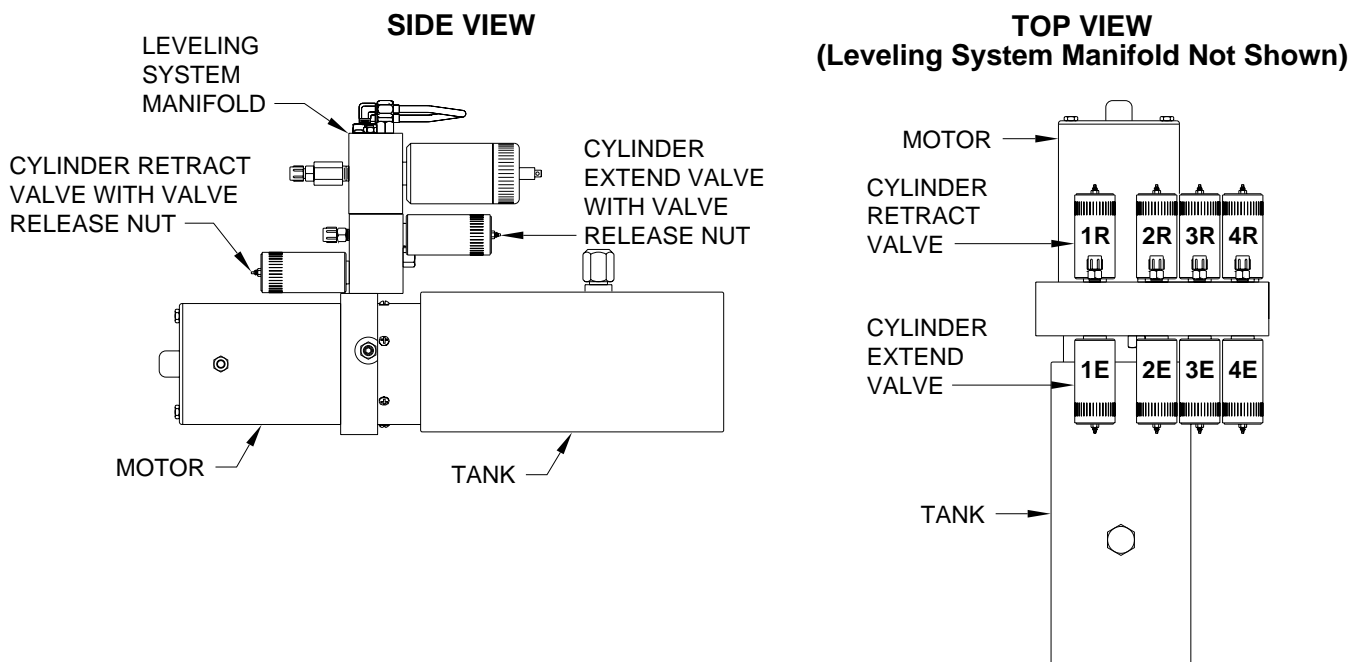
When there are multiple rooms, such as shown below, it is important to determine which set of valves (Cylinder Extend and Cylinder Retract) operate a particular room. Although the valves may be labeled it is a good idea to check that you have the correct pair of valves. Do not depend on the diagrams in the owners manual. The vehicle manufacturer may not have used the HWH diagram when wiring or plumbing the assembly.

**NOTE: Due to the designs of different rooms, Room Extend or Room Retract is not always the same as Cylinder Extend or Cylinder Retract.**

If the room is operating correctly, unplug one set of Cylinder Extend and Cylinder Retract valves at a time and try to operate the room. When the room will not extend or retract, the correct set of valves have been located.

If the room will not operate, unplug one valve (Cylinder Extend or Cylinder Retract) and check for +12 volts between the two pins in the harness plug while someone pushes the room control switch to Extend AND Retract. When voltage is present while the switch is being pushed, the correct set of valves have been located.

**IMPORTANT: Open both the Cylinder Extend and Cylinder Retract valves for a room to release pressure before replacing one or both valves for that room. Turn the Valve Release Nuts NO MORE THAN 4 1/2 full turns counter clock wise to open the valves. Remember to close the valve(s) after the repair is complete. Tighten the Valve Release Nuts snug only. DO NOT over tighten.**

**NOTE: Make sure the o-rings for the old valve did not come off and stay in the manifold. Compare the old valve to the new valve to make sure.**
